## Fuel Hose Connections in the ASH-26E

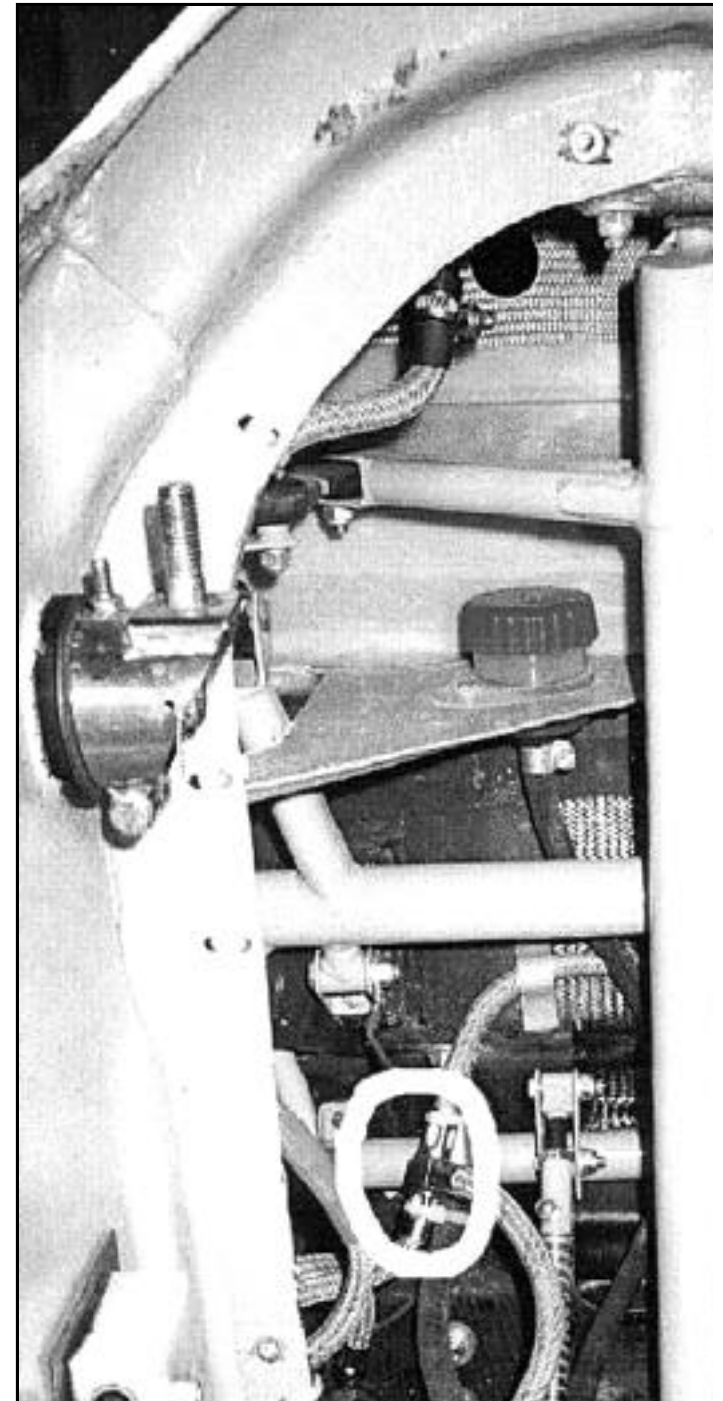
Photo of the center compartment of Eric Greenwell's ASH 26 E, with the fuel line fitting circled that was leaking on Jerry Plaszowieki's 26E. Clearly seen is the crimping of the fittings. An uncrimped fitting would be obvious. The paragraphs below are a short description of the incident.

revealed that the leak originated from the "T" fitting between the fuel pumps and the engine fuel feed line. One of the fittings on the "T" had not been crimped! Fortunately, this line was the short link between a fuel pump and the "T", and the fuel pump pressure was insufficient to force the hose completely off the "T". This was the only fitting in the fuel system that was found to be faulty.

Because replacement hose could not be quickly obtained from Schleicher, the original fitting was crimped to secure it. New hoses were ordered.

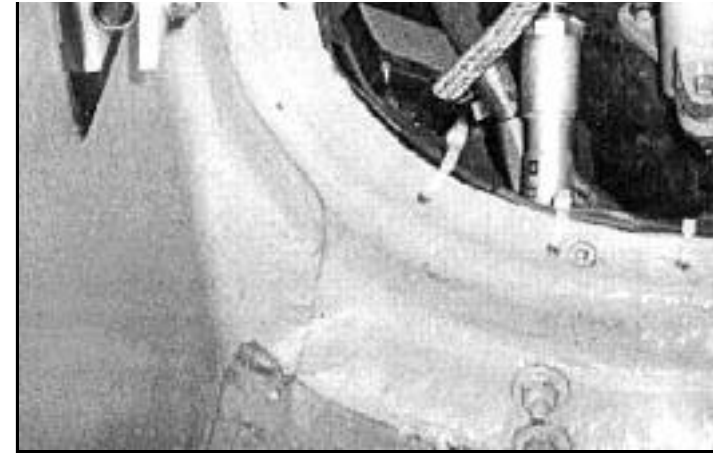
A small access panel in the wheel well allowed us to insert a mirror, and with a flashlight we located a blue-stained fuel hose fitting that was damp to the touch. This compartment contains some of the control linkages, and more importantly, the ignition modules, fuel pumps, and alternator voltage regulator, raising the possibility of a fire or explosion caused by a spark from these items if the engine was used. No further fuel leaked into the compartment when the fuel shut-off valve was closed, so Jerry did finish the contest, but without relying on the engine for self-retrieve.
